# Manhole Inspection Summary

Manhole # S15CC2013MH

Insp Date: **7/26/06 11:48 AM**

**Location** Address: **2007 SULGRAVE RD**

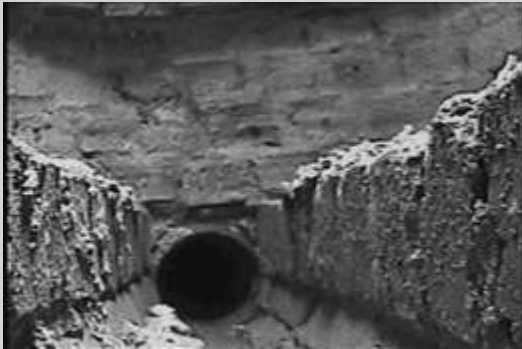
### 8 in. Circular Gravity Sewer Pipe Out @ 12 O'Clock

Pipe Material: **Clay** ☐ Pipe Lined

Invert Depth: **4.35** (ft.) Flow Characteristics: **None**

Deposits: ☒ None ☐ Mud ☐ Sludge ☐ Debris ☐ Grease

Infiltration: **None** Pipe Seal Cond: **Unknown**

Drop: **None**

Connects To: **Manhole**

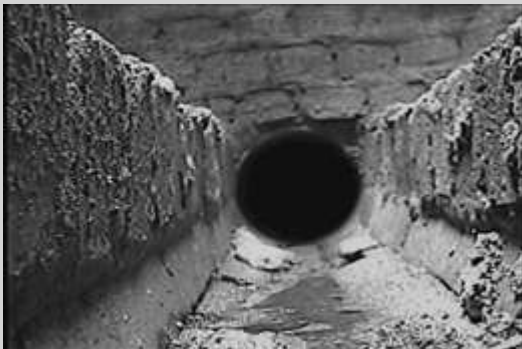
### 8 in. Circular Gravity Sewer Pipe In @ 6 O'Clock

Pipe Material: **Clay** ☐ Pipe Lined

Infiltration: **None** Pipe Seal Cond: **Unknown**
